Re: Lead-based Paint Survey (for RRP Compliance)
March Air Force Base
Buildings 940, 942 and 960
Moreno Valley, California 92581

Project No: 39361

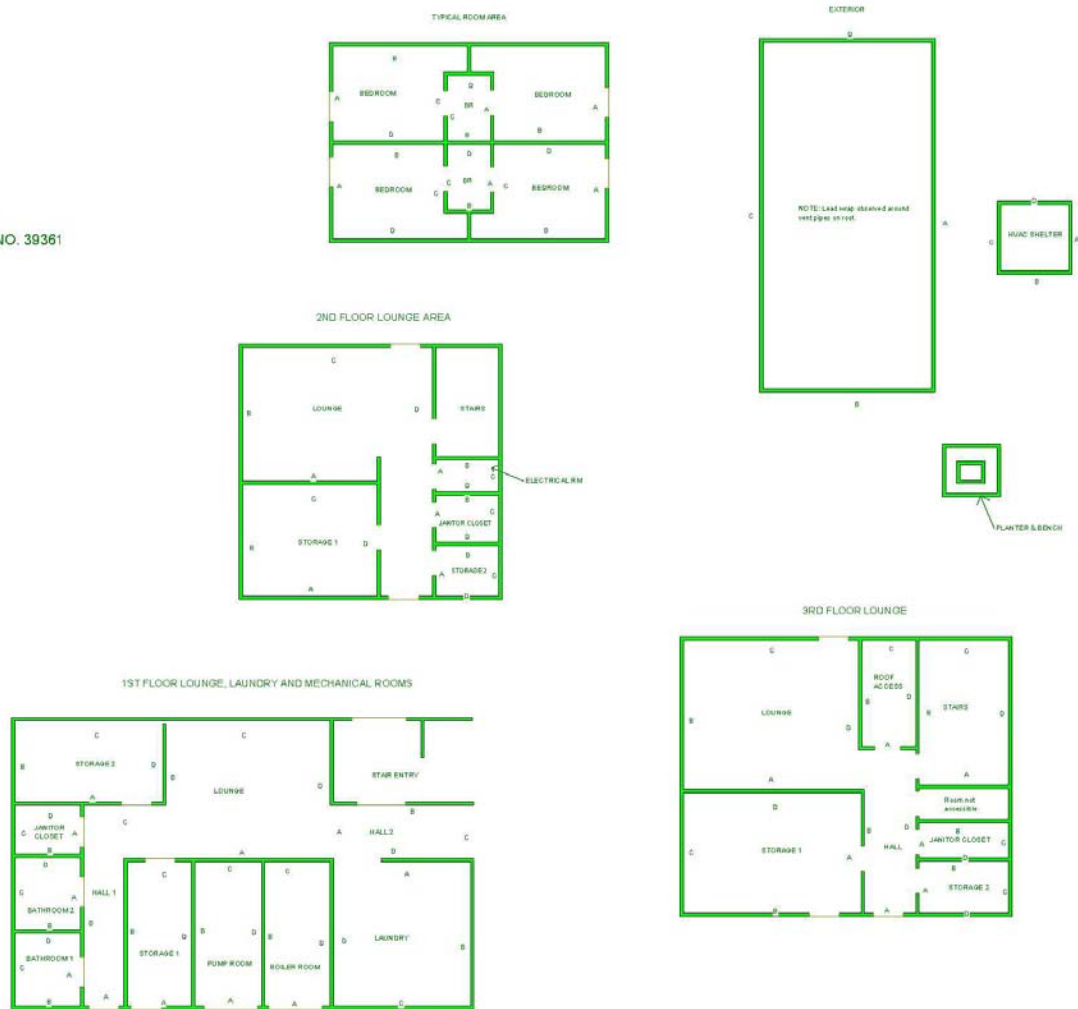
SITE PLAN

MARCH AFB
 BLDG 940
 RIVERSIDE CA
 PATRIOT PROJ NO. 39361
 XRF SURVEY

Note: The exterior front side of the building is labeled as Side "A". Sides B, C & D proceed clockwise from side A.

Entries to each room or room equivalent is Side "A" for building interiors. Sides B, C & D proceed clockwise from side A.
